# TROUBLESHOOTING

## Hydraulics

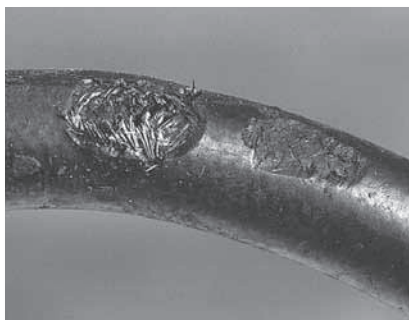
### Abrasion

**Problem:** Part of the hose cover has been removed, exposing the hose reinforcement.

This may be caused by continuous rubbing against equipment components, other hose or objects in the operating environment. Cover erosion may also be caused by non-compatible fluids such as toxic chemicals, acids, detergents and non-compatible hydraulic fluids. Exposed hose reinforcement is susceptible to rust and accelerated damage leading to failure.

##### 1. Reroute hose.

Bundle hoses together that flex in the same direction. Clamps, bent tube couplings, nylon ties, spring guards and sleeving can be used to keep hoses away from abrasion sources and exposure to non-compatible fluids.

##### 2. Protect hose.

Nylon and urethane sleeving and spring guards can be used to protect the cover from abrasion. See page 62 for more information.

##### 3. Change to a hose with a cover that is compatible with any chemicals it may contact.

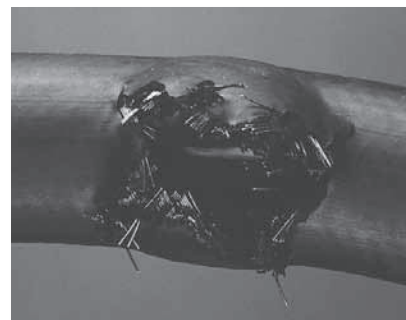
### Hose Burst at Body

**Problem:** The hose has burst at some length away from the hose ends.

This may be caused by excessive pressure surges, flexing, kinking, crushing or exceeding minimum bend radius.

- Pressure surges that exceed the hose's maximum operating pressure rating may result in reinforcement failure.
- Excessive flexing, kinking, and crushing causes reinforcement fatigue and eventual failure, i.e., flexing a metal paper clip back and forth until it breaks.
- Bending the hose tighter than recommended will place excessive stress on the reinforcement, could open large gaps between strands of reinforcement, and will severely reduce the hose's ability to withstand pressure.

Review/inspect your operating pressure. It may be necessary to use a pressure transducer to measure the magnitude of any pressure surges. Select a hose that has the proper working pressure rating to handle the maximum pressure (including surges) of your application. If your application has frequent pressure

surges, you may want to consider a spiral wire-reinforced hose rather than a wire braid-reinforced hose

Reroute hose to eliminate excessive flexing and/or exceeding the minimum recommended bend radius for the hose in use. Use a hose that has a smaller bend radius.

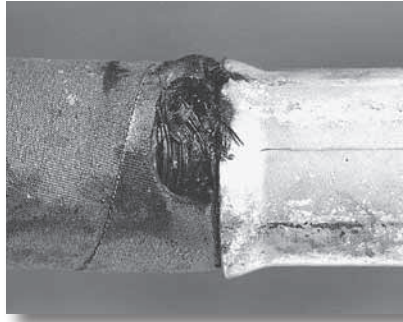
### Hose Burst at Coupling

**Problem:** Hose has burst at coupling end.

This may be caused by insufficient hose slack, excessive bending/flexing or an overcrimped hose end. When a hose is pressurized, it typically shortens in length putting excessive stress (tug) at the coupling. Excessive bending or flexing increases stress of the reinforcement. Overcrimping or use of the wrong ferrule will damage or crush the reinforcement, severely limiting its ability to withstand pressure.

Increase hose length to accommodate contraction under pressure. Increase actual bend radius as the hose exits the coupling

Bend restrictors can also be used to reduce bending stress at the coupling. Replace hose assembly with properly crimped assembly.

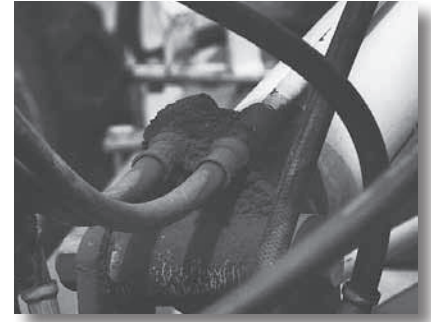
### Leak at Thread End/Seat

**Problem:** Coupling leaks at thread or seat.

This may be caused by any of the following:

1. Missing or damaged O-ring.
2. Damaged threads or seat angle.
3. Thread misalignment.
4. Incompatible thread ends or seat angles.
5. Over or undertorquing.

Remove the connection and inspect.

1. Certain couplings require the use of an O-ring. If it is missing, replace it. If an O-ring is used, check for damage caused by installation or possible material breakdown from heat or fluid incompatibility. Alternative O-ring materials may be required. Replace if necessary.
2. Check the threads and/or seat angle for damage that may have occurred prior to or during installation. Any ding or burr may be a potential leak path. Replace if necessary.
3. If the coupling was misaligned during installation, threads may have been damaged. Replace and carefully reinstall.

4. It is possible to thread together some components that are not compatible. Use Gates thread I.D. kit to assist in identifying mating components. Some thread end configurations have better sealability than others.

5. Overtorquing of a threaded connection can stretch and damage threads and mating seat angles. Overtorquing can also damage the staking area of the nut. Overtorquing can cause cracking of either the nut or seat. Undertorquing does not allow

Use of a torque wrench can alleviate such problems.

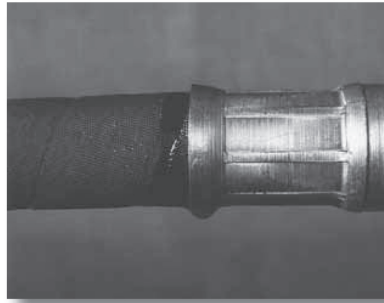
### Weep at Hose Coupling Interface

**Problem:** Fluid is seeping or weeping from the end of the ferrule.

This may be caused by insufficient hose insertion during assembly and/or undercrimping/overcrimping. Also, excessive vibration, flexing and tugging may weaken the interface and reduce the assembly's ability to prevent fluid seepage.

Whether it has been undercrimped or the stem has been improperly inserted, the hose assembly must be replaced with one that has been properly assembled.

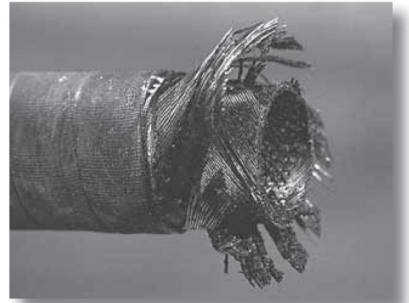
### Coupling Blow-Off

**Problem:** The crimped coupling comes off the end of the hose.

This may be caused by any of the following:

1. Under or overcrimping.
2. Incorrect crimping dies.
3. Improper skive (if applicable).
4. Incorrect fitting/hose combination.
5. Ferrule not engaged into the stem locking collar (if using two-piece coupling).

Insufficient hose slack in routing will cause the hose to pull away from and release the coupling. Mixing various manufacturers' hose and couplings may also reduce coupling retention.

**Solution:** Examine and replace the hose assembly to ensure proper assembly procedures are followed.

Modify hose length and/or routing to accommodate potential hose length reduction under pressure

Never mix different manufacturers' hose, couplings or crimpers.

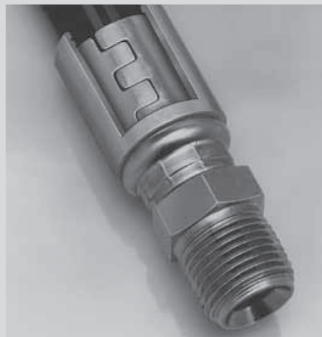
Gates revolutionary MegaCrimp® coupling has

been designed to provide "weep-free" performance as well as easy/simple insertion.

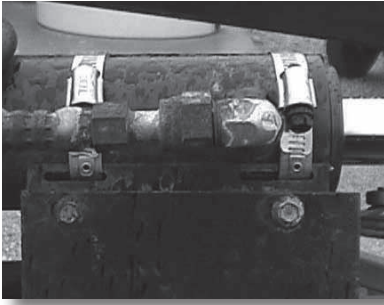
### Coupling Corrosion

**Problem:** Coupling has been exposed to corrosive conditions that have begun to cause rust and deterioration. Chemicals, fertilizers, humidity or a marine environment could be the cause of the corrosion.

Many hydraulic fittings are manufactured from carbon steel and have zinc dichromate plating that provides minimal corrosion resistance. SAE J516 requires manufacturers to pass a 96-hour continuous salt spray test.

Provide adequate protection for the coupling or minimize exposure to corrosive elements. Other coupling materials, such as stainless steel and brass are available and can provide better resistance to some corrosive elements.

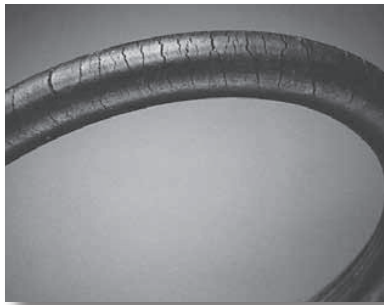
### Hose Cracks

**Problem:** Hose cover or tube has cracks and appears hardened.

This is typically caused by exposure to excessive heat and/or ozone. Excessive heat can be created by:

- Routing near a heat source such as an exhaust manifold.
- Using an undersized hose or reservoir.

An increase of 18°F above the maximum temperature may decrease hose life by half. Cracks can also be caused by flexing, especially at excessively low temperatures. Never exceed the temperature rating of the hose.

Select a hose that meets the temperature and flow requirements of the application. Also, identify the heat source and consider re-routing it away from the source to minimize the heat's effects. Examine reservoir size (if necessary).

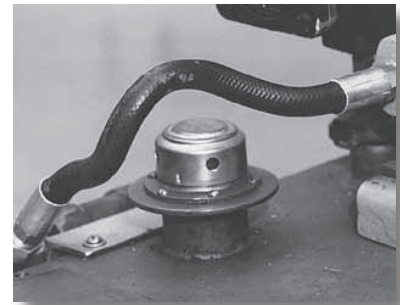
### Hose Twist

**Problem:** Hose assembly is twisted.

This is evident by a spiraling hose label and bends in two planes, as demonstrated in the photograph above. Twisting misaligns the reinforcement and reduces its ability to withstand pressure. Twisting a high-pressure hose seven degrees may reduce service life by as much as 90 percent.

Replace and re-route the hose to ensure that bending occurs only in one plane (see below). The use of bent tube or block style couplings and adapters may improve routing. Also, when installing the assembly, hold the backup hex to prevent it from turning and applying a twist. If male and female couplings are used on the same hose assembly, install the male (non-swivel) end first.

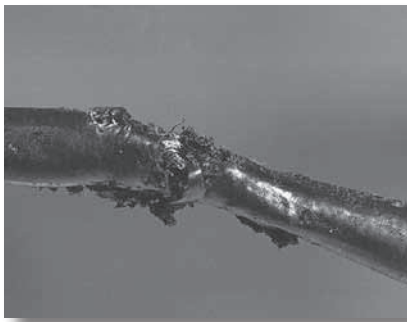
### Crushed Hose

**Problem:** Hose has been crushed.

Flattened area has been caused by external forces (movement). Reinforcement is weakened and could burst. Also, the tube has collapsed restricting fluid flow.

Determine source of damage. Re-routing or guarding may be necessary. Replace hose.

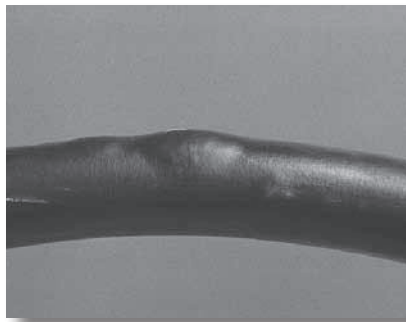
### Cover Blisters

**Problem:** Blisters have formed on the hose cover.

This can be caused by incompatible fluids that have permeated the hose tube and collected under the cover. Compressed gases can also permeate or effuse through the tube and become trapped under the cover. Trapped air in the hydraulic system can also cause blisters.

Replace the hose with one that is compatible with the fluid being used. If it is compressed gas, the cover can also be perforated (pin-pricked) to allow the gas to pass through the cover. Textile hose covers also eliminate blistering. Bleed the system to eliminate any trapped air.

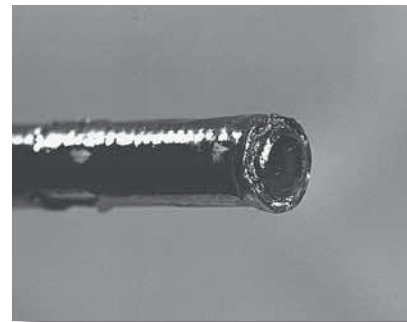
### Tube Swell

**Problem:** The equipment has become sluggish and unresponsive.

Cutting and evaluating the hose shows the hose tube is swollen and deteriorated and possibly washed out in sections. Fluid incompatibility is the likely cause. Many new fluids are now promoted as "environmentally friendly" but may not necessarily be compatible with the hose.

Excess fluid temperatures can also cause the tube to bulge near the end of the coupling.

Replace the hose using a tube material recommended for that particular fluid.

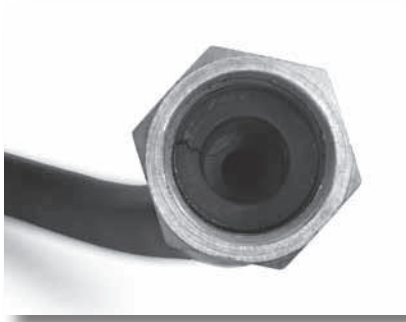
### JIC/SAE Seat Cracks

**Problem:** Fitting sealing cone seat is cracked.

If crack is due to overtorquing, use torque wrench and follow recommended torque specifications. If crack is due to excessive vibration or shock loading, change hose routing to reduce side load on fitting.

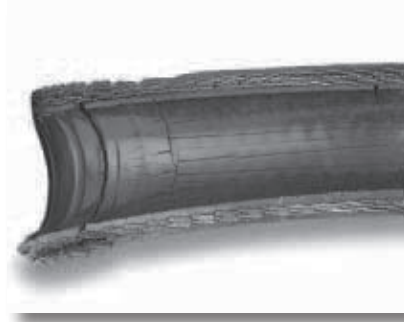
### Hose Tube Failure

**Problem:** Hose tube failure – tube material is cracked and brittle. High temperature caused by excessive fluid velocity.

Compare pump output to the hose size using flow rate chart. Select a hose type with a higher temperature rating. If not possible, add cooling devices and increase reservoir size.

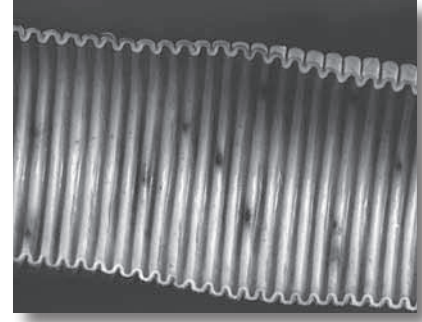
### Static Discharge On Teflon® Hose

**Problem:** Pinholes in Teflon® tube that allow fluid to escape through the cover.

Dissection of tube shows black “burn” areas and pinholes. This is caused by a release of an electrostatic charge through the tube to the wire cover. Some fluids have the potential for electrostatic buildup.

Replace damaged hose with one that has a conductive tube (Gates C14 conductive tube). This allows any charge to be conducted to the end fittings rather than discharging through the tube wall.

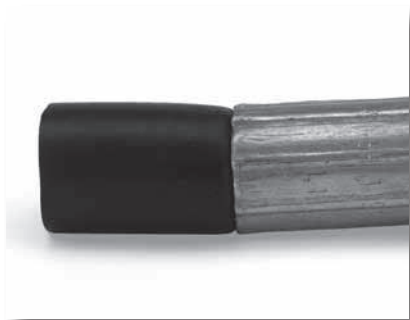
### Overcrimp

**Problem:** The ferrule appears to be overcrimped which could lead to leaking or premature failure.

Refer to the crimp manuals or charts for proper die selection and crimp settings. Receive hands-on training for fabricating hydraulic assemblies. Use Gates calipers to measure the finished crimp diameter for accuracy. Crimp O.D. tolerance is +/- .010 (in.).

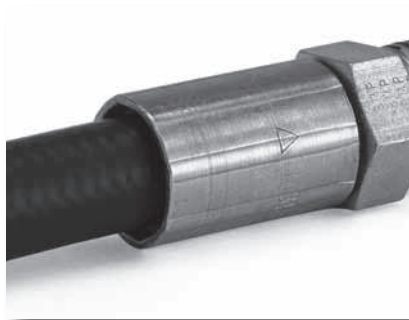
### Undercrimp

**Problem:** The ferrule appears to be undercrimped which can lead to coupling leaks or blow-offs.

Refer to the crimp manuals or charts for proper die selection and crimp settings. Receive hands-on training for fabricating hydraulic assemblies. Use Gates calipers to measure the finished crimp diameter for accuracy. Crimp O.D. tolerance is +/- .010 (in.).

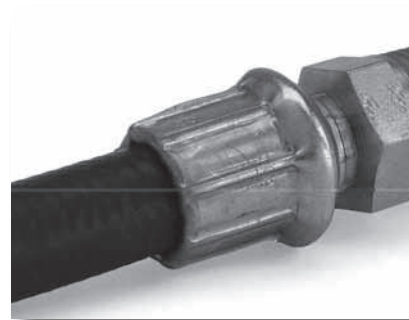
### Mushroom Flare Crimp

**Problem:** The crimp of the ferrule is not full length, leaving a mushroom flare at the top of the ferrule. This could lead to coupling blow-off or early failure.

With the Gates crimping system, be sure that the ferrule or shell is fully engaged with the dies to ensure a full-length crimp. Refer to Gates crimp manuals and charts for proper crimping instructions. Receive proper training on crimping procedures with the Gates hose and coupling system.

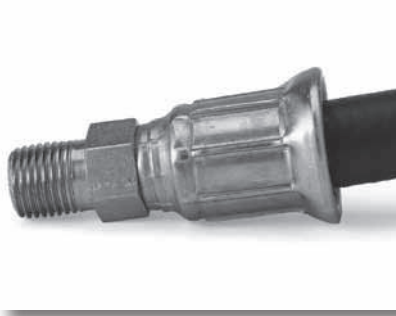
### Tail-Flare Crimp

**Problem:** The crimp of the ferrule is not full length, leaving a tail flare at the end of the ferrule.

With the Gates crimping system, be sure that the ferrule or shell is fully engaged with the dies to ensure a full-length crimp. Refer to the Gates crimp manuals and charts for proper crimping instructions. Receive proper training on the crimping procedures with the Gates hose and coupling system.

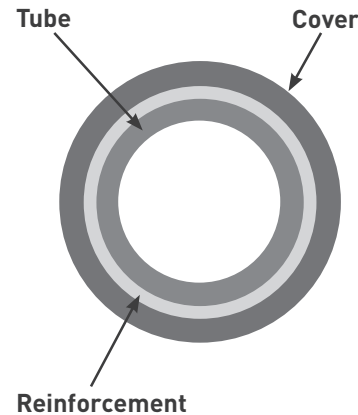
A hose is generally made up of three components:

**1. Tube:** The tube's function is to contain the material conveyed. Refer to the chemical resistance charts and characteristics of hose stock types in Gates hydraulic catalog to identify material for a specific fluid.

**2. Reinforcement:** The reinforcement is the hose's muscle. It provides the necessary strength to resist internal pressure (or external pressure in the case of suction/vacuum).

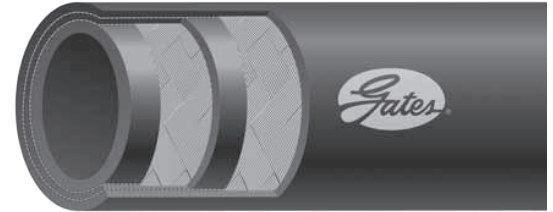
**Braided** reinforcement can be wire or textile and can have single or multiple layers.

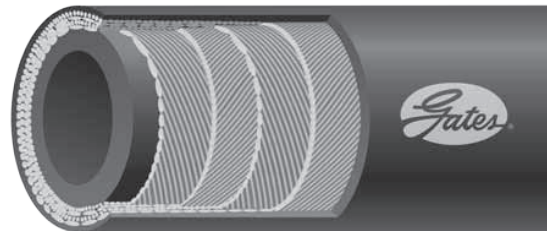
**Spiraled** reinforcement on hydraulic hose is typically wire or textile and has four or six layers (plies). Spiral-reinforced hose can typically handle more severe applications with longer impulse service life.

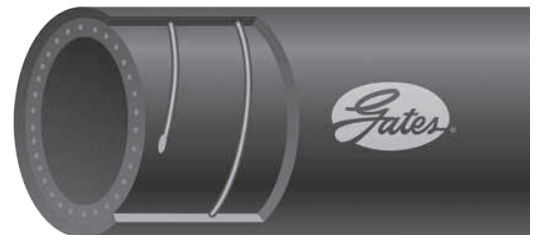
**Helical** coil reinforcement keeps the hose from collapsing during suction (vacuum) and tight bending.
