# NTN's LLU Seals Expected to Triple Uptime at Cold Rolling Mill

# NTN LLU SEALED DEEP GROOVE BALL BEARINGS

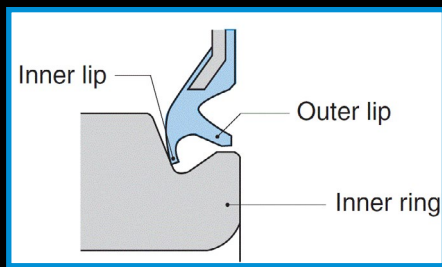
## Grooved Type Sealing Figure for Excellent Performance (All Models)

A v-shaped groove is cut around the inner ring. Under centrifugal force, the outer surface of the 'v' acts to keep out dirt; the inner surface of the 'v' acts to seal in the grease.

## Double-Lip Seal Adjusts to Wear (LLU Spec)

The inner lip of a double-lip seal is pressed against the inside surface of the V-groove; the outer lip is spread open by the elastic force of rubber to create a small gap between the outer lip and the inner ring. Should the inner lip wear, the contact pressure will decrease; however, the outer lip will get closer to the inner ring. In effect, a constant degree of sealing will be maintained; and, as a result, bearing service life will be noticeably lengthened.
