TRADITIONAL WING BENDING & FOLDING SOLUTION

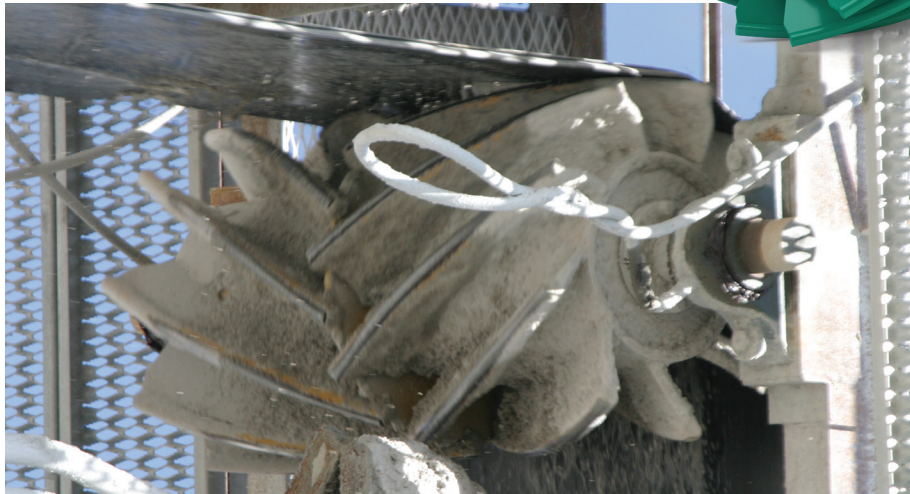
A medium sized quarry was experiencing pulley failures with traditional wings due to large material bending and folding the wings.

The professionals at PPI worked with the customer to replace all of the standard wings with PPI Herringbone Wings® with abrasion resistant bar. The extreme wing angle, of up to 45 degrees, uses the pulley's rotation to eject material rather than recirculating it as a conventional wing often does. The material ejection along with AR bar extended the life of the pulleys.
